Asset Management Plan 3 Waters 2014

Rangitikei District Council

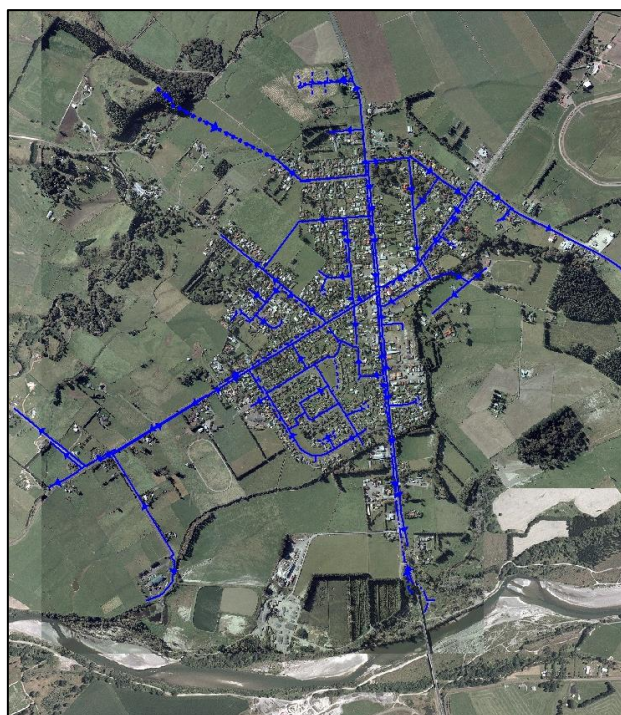
Figure 14: Extent of Bulls Water Scheme

The Bulls water network is depicted in Figure 14.

Key issues for Bulls water are:

- Network modelling and data collection to ascertain the condition and performance of pipes and fittings for this scheme is a high priority.
- Highly critical rising mains are located on State Highways. These mains are predominantly AC pipes.
- Removal of some of the older AC pipes in the reticulation system that are now showing signs of weakness.
- Addressing corrosion of metal fittings and domestic water heater elements.
- Reduction of water losses within the water reticulation system.

The Bulls water network comprises 27.4 km of pressure mains ranging up to 200 mm diameter. Approximately two-thirds of all the pipes are asbestos cement (AC) pipes laid in the late 1960s and 1970s. This material was superseded in the late 1970s by MDPE and PVC, which now account for 30% of the network. There is a small portion of the network built from copper which is known to be in poor condition.

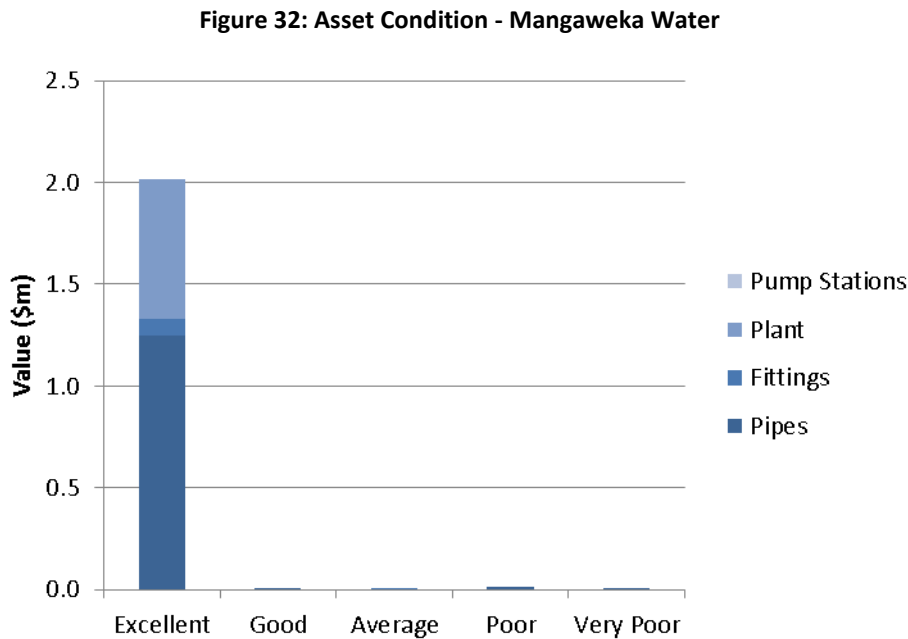
Asset condition for Mangaweka water is summarised in Figure 32. Almost all assets have been assigned “Excellent” condition.

The original rising main has now been replaced except for 55 m remaining in 125 mm steel pipe. The only other concern in this main is the existence of galvanised iron where the pipe passes through the railway corridor. It would be desirable to replace this with a more acceptable material, such as ABS.

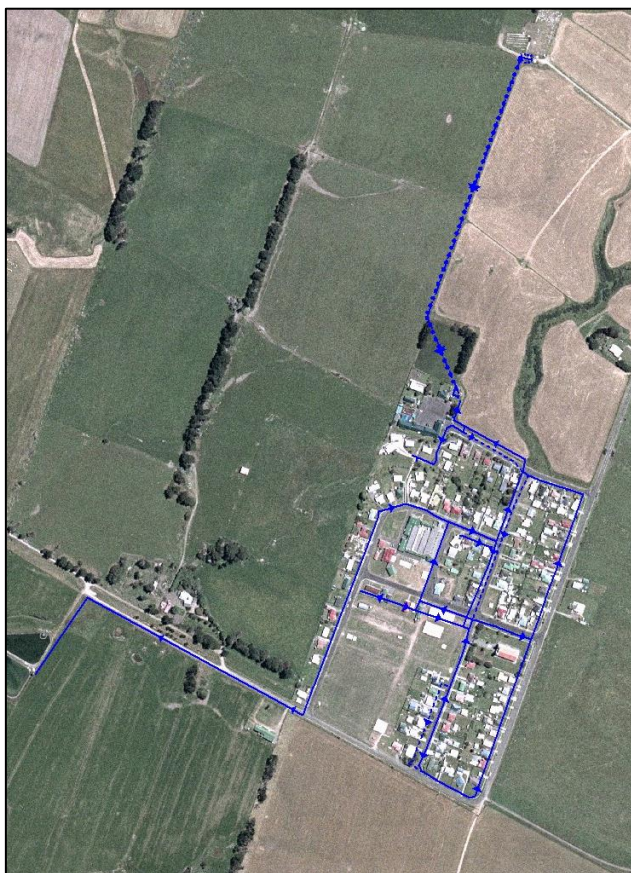
Figure 42: Extent of Ratana Water Scheme

The Ratana water scheme is shown in Figure 42.

The key issues in Ratana with respect to water are:

- Supply is not accepted by the community as prime source of potable water.
- Poor quality of source water and associated treatment requirements required to meet NZ Drinking Water standards are uneconomic for this community.
- Network modelling and data collection to ascertain the condition and performance of pipes and fittings for this scheme is a high priority.
- High levels of iron, manganese and hardness in the source water and limited capacity for a regular flushing programme.
- Short duration high peak demands during holiday periods.
- Increased volume of water storage required to provide system supply security during summer months.
- High risk of delivery failure with only one booster pump installed.
- The annual (January) festival in Ratana puts a strain on the system as the population increases from approx. 500 people to several thousands. Extra water is tankered in to cope.

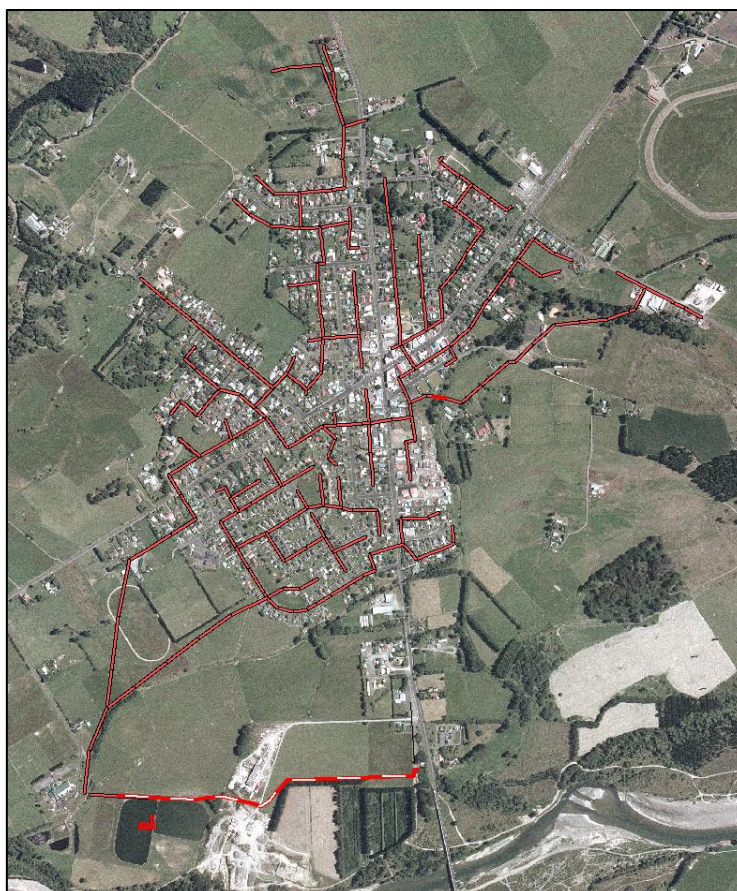
Figure 74: Extent of Bulls Wastewater Scheme

The extent of the Bulls scheme can be seen in Figure 74.

Key issues include:

- Improved grazing and weed control around the oxidation ponds is required, especially the outfall.

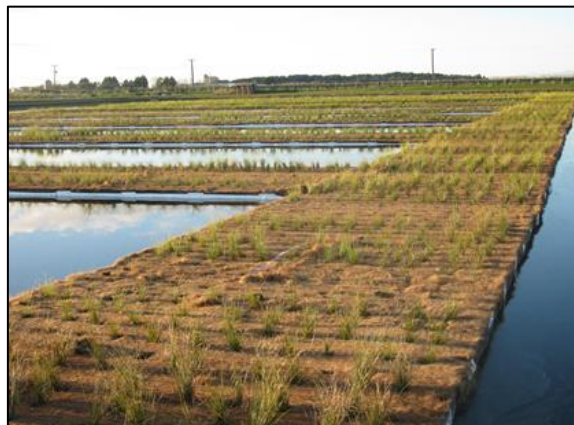
Figure 81: Hunterville WWTP

The floating media at the Hunterville WWTP is shown in Figure 81.

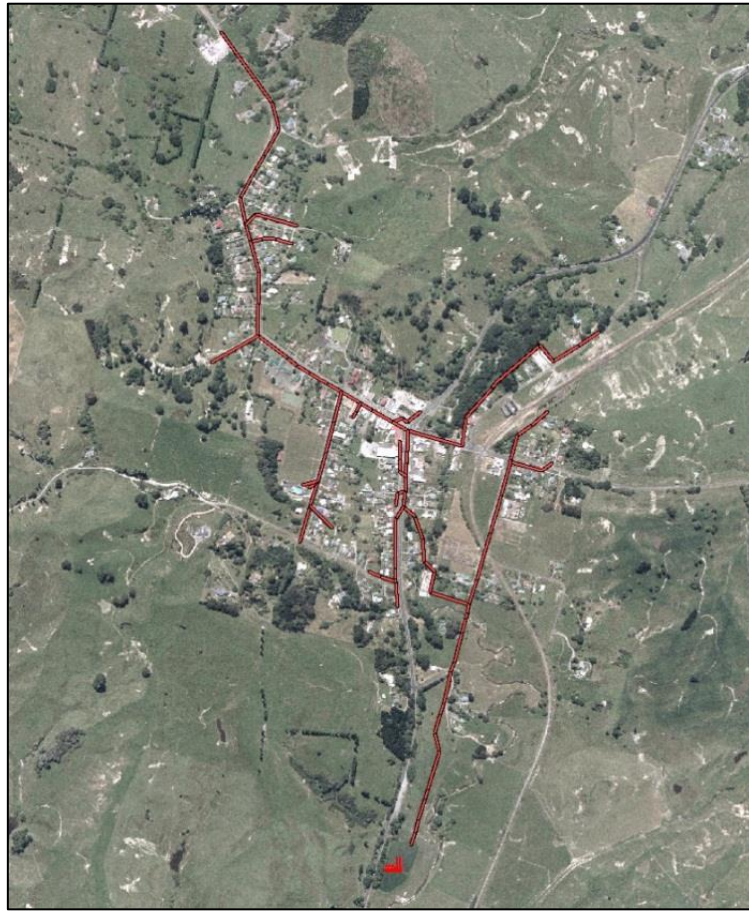
Figure 82: Extent of Hunterville Wastewater Scheme

The extent of the area served by the Hunterville wastewater scheme can be seen in Figure 82.

Key issues for Hunterville wastewater are:

- The system is old and there is significant infiltration and inflow.
- The remainder of the network is PVC pipe laid in the mid 1990s. It is in good condition and is not expected to require maintenance in the near future.
- The oxidation pond is undersized for the current demand, even without infiltration or inflow considerations.

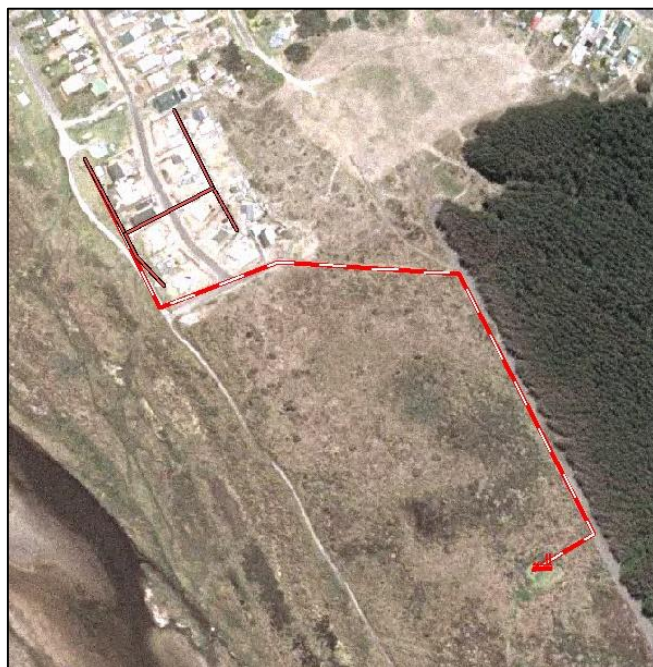
Figure 89: Extent of Koitiata Wastewater Scheme

Figure 89 shows the extent of the Koitiata wastewater scheme.

The key issues relating to the scheme are:

- This scheme has been built for the subdivision that it serves and cannot be added to without considerable investment by Council.
- Koitiata is seen as an area of potential growth. Properties with old septic tanks may be refused to replace them when they fail.
- The pumping line may be subject to vehicle damage in the soft sand country.
- Work is required to fully comply with consent conditions.

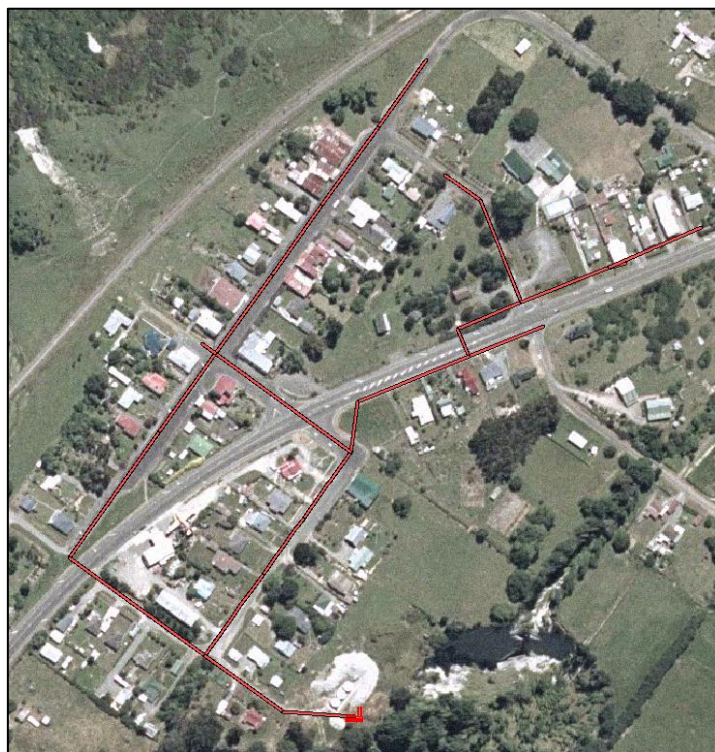
Figure 96: Extent of Mangaweka Wastewater Scheme

The extent of the Mangaweka wastewater system is shown in Figure 96.

Key issues at Mangaweka:

- Much of the old earthenware system is prone to infiltration.
- Some stormwater inflow is suspected to come from private property.
- Some pipes cross underneath the State Highway or through private property, which makes renewal or repairs more difficult.

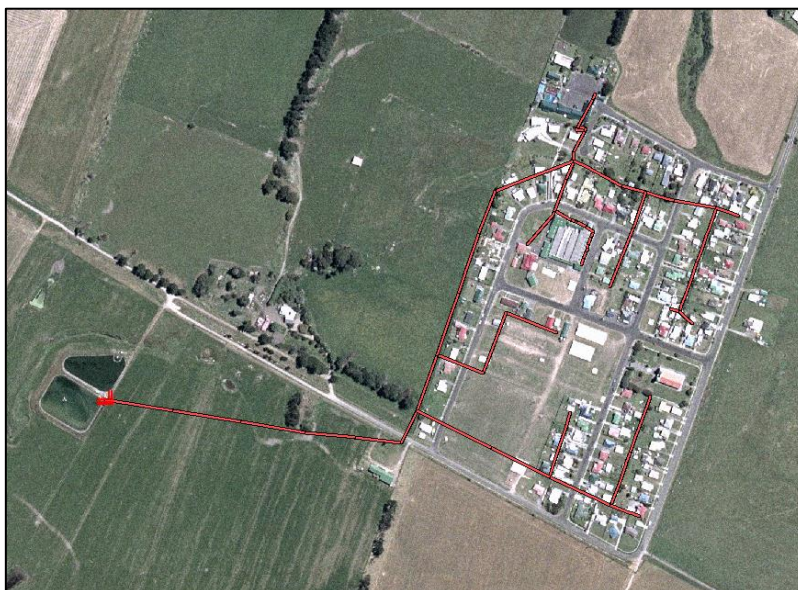
Figure 110: Extent of Ratana Wastewater Scheme

The extent of the Ratana scheme is shown in Figure 110.

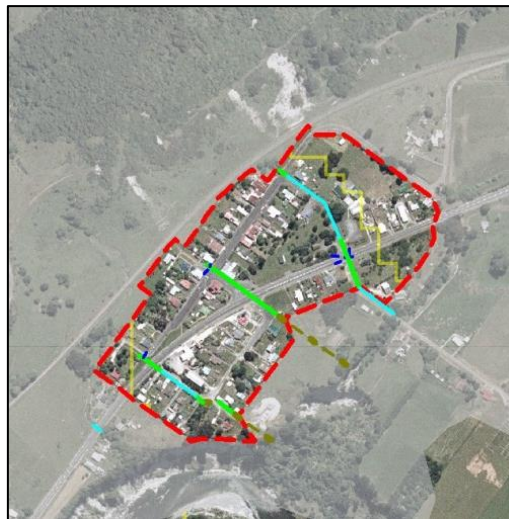
Figure 138: Extent of Mangaweka Stormwater Scheme

The extent of the stormwater scheme for Mangaweka is shown by Figure 138.

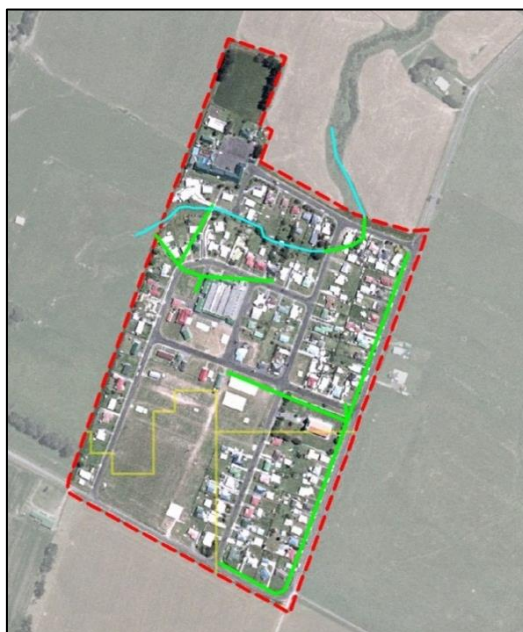
Figure 151: Extent of Ratana Stormwater Scheme

The Ratana stormwater system is shown in Figure 151.
